The *Miracle* Stainless Steel Cover Track solution for window rail repairs

The new 220630 *Miracle* Stainless Steel Cover Tracks can be used over damaged window tracks to restore new life. An easy to fit and cost effective lifetime solution. Unlike aluminum, the *Miracle* track is so tough that normal drill bits will go blunt trying to drill into it.

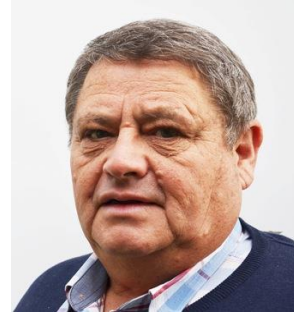
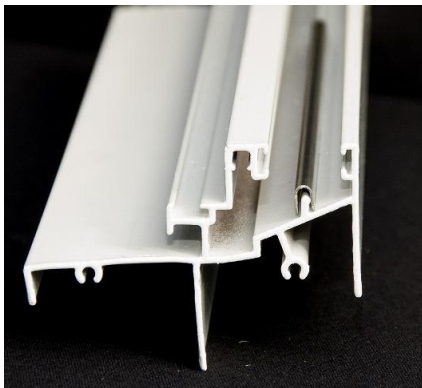
Step 1. Measure and cut track to length then test fit. Clean track to be free from dirt, oils etc.

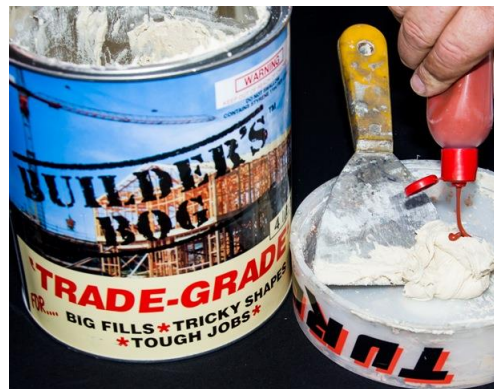
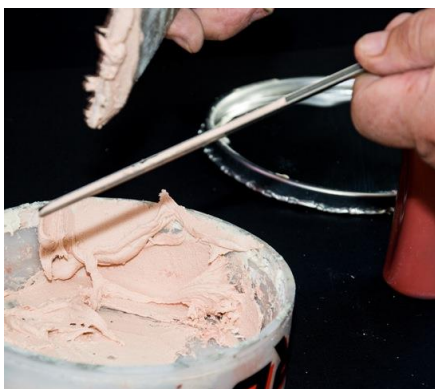
Step 2. Mix polyester filler product to fix tracks. Use less hardener for a slower setting time or if confident use more hardener for a fast setting time.

Step 3. Using a flat blade, fill the *Miracle* Stainless Steel track with the mixed polyester product. Use the flat blade to remove excess from back of track.

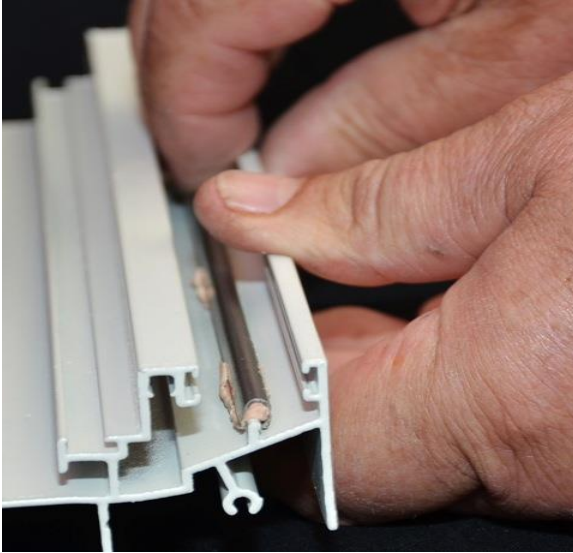
Step 4. Push cover track over existing track and press down to squeeze out resin filler. Do not worry about cleaning up any excess resin filler at this stage. Very important to have track seated before resin filler begins to gel.

Step 5. Once resin filler has gel set, use a flat screwdriver blade to run along both sides to clean out excess filler product. This is a quick and clean process. Use a vacuum to suck out loose material and job is done.

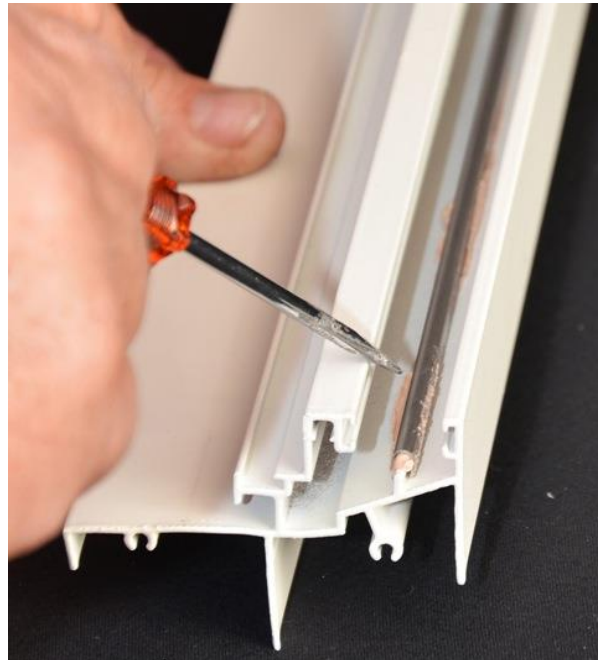
The new cover track once installed is there for life and is very hard to damage. All that is left is to replace the window sash and see just how well it now runs.
